# Final Report

### ALUMINUM PIPE CULVERTS

Joint Highway Research Project

Purdue University Lafayette, Indiana September 24, 1965

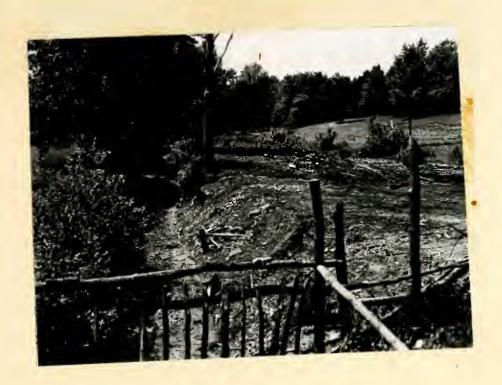
Figure 1 - Drainage area for culvert pipe No. 1. Road on the right of stream is an old coal haul road.

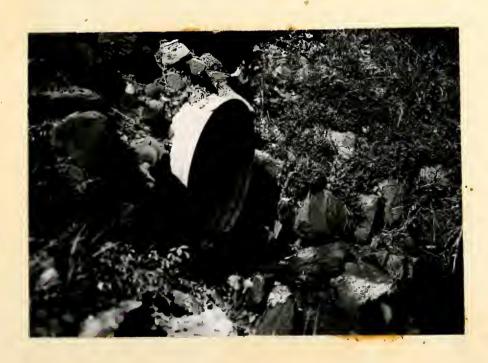
Figure 2 - Down stream end of culvert No. 1. V-shaped notch was cut out during an earlier inspection.

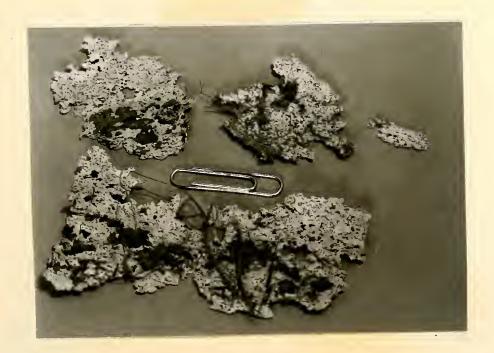
Figure 4 - Specimen removed by hand from the invert of culvert No. 1.

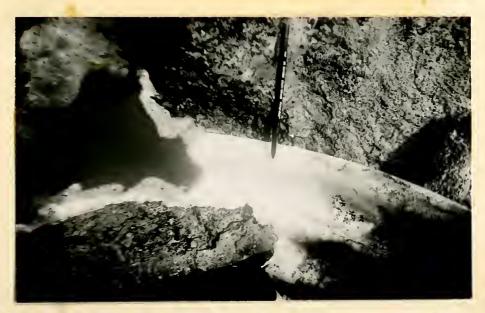
If one was to casually inspect this pipe, it would be quite feasible to conclude that there was no apparent corrosive attack. However, when the coal and the muck residues that covered the invert of the pipe with six inches of material were removed, the pipe showed signs of severe attack (Figure 6). In Figure 6 a white crusty material can be seen in the vicinity of the pen point, the region covered with the muck. This white material is probably aluminum oxide and its adherence to the parent material was strong. It was impossible to remove any portion of it by hand to analyze. It appears likely that as long as this material is not subjected to abrasive wear from stream bed materials, the rate of corrosion will be inhibited by this oxide coating. Much valuable information could be gained if this pipe was inspected on a six-month basis for a few years to ascertain how the oxide coating contains the acid attack.

Figure 6 - The invert of the down stream end of culvert No. 2.
